ORDINANCE NO.: ORD. NO. 11554-2026

**AN ORDINANCE DETERMINING THAT CERTAIN REAL PROPERTY LOCATED IN THE CITY OF BROOK PARK CONSTITUTES A "BLIGHTED AREA" AS SUCH TERM IS DEFINED IN OHIO REVISED CODE CHAPTER 725; AND DECLARING AN EMERGENCY.**

# Brook Park Blight Study

Former Brook Park Ford Plant

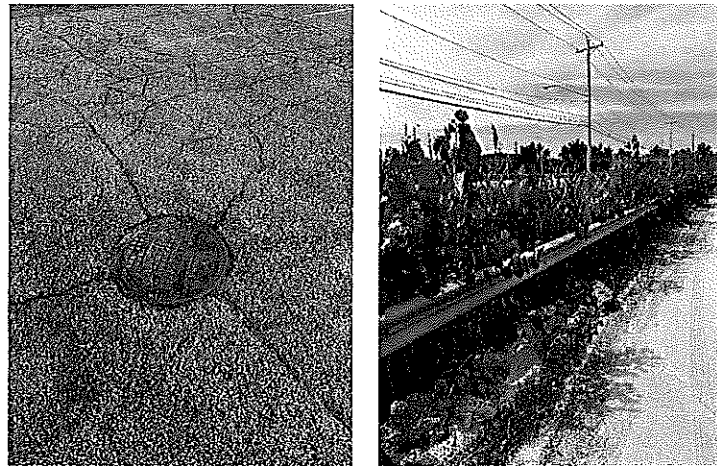
Figure 6: Cracked asphalt pavement; failing safety guardrail. McBride Dale Clarion site evaluation photos, Photos Captured: 24 July 2026.

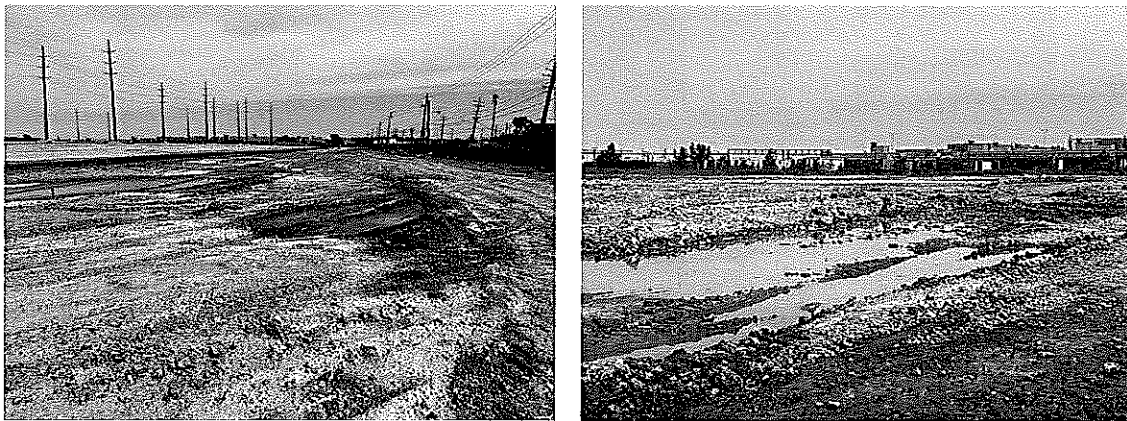
The presence of a defective or inadequate street layout was observed from the subject area access points. Off-site improvements providing vehicle access include 10 curb entrances and two (2) signalized traffic signals. There are no improved roadways on the subject area and entrances are gated off.

*Figure 7: There are no finished streets or lighting infrastructure on the Former Brook Park Ford Property. McBride Dale Clarion site evaluation photos, Photos Captured: 24 July 2026..*

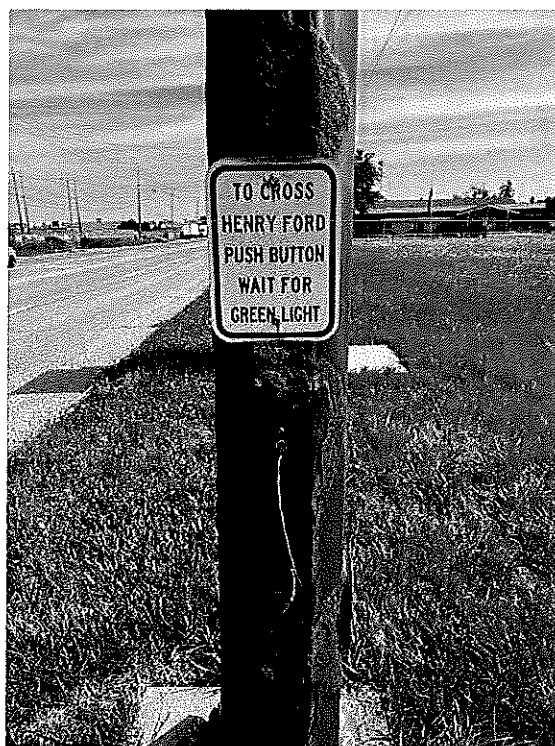
*Figure 10: Off-site traffic light pole is rusted and deteriorating (located Northeast of intersection of Hummel Road and Engle Road). McBride Dale Clarion site evaluation photos, Photos Captured: 24 July 2026.*

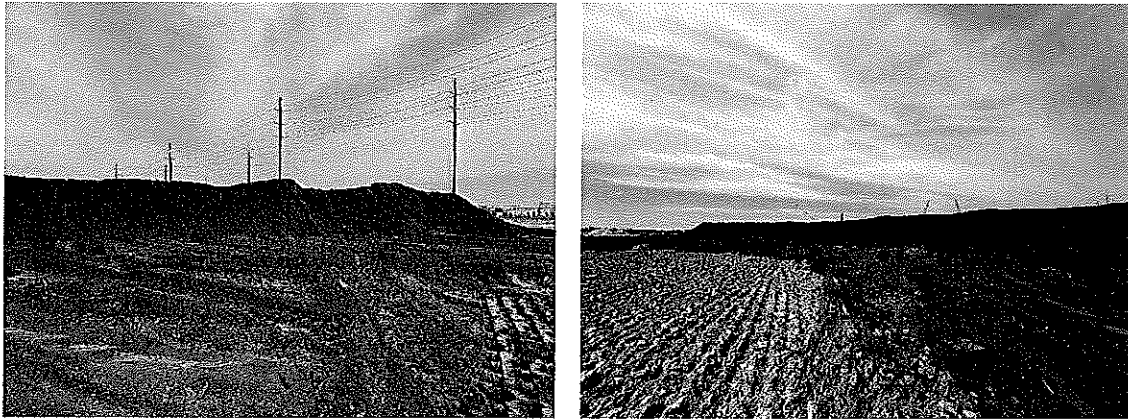
Another contributor is the presence of "Foundry Sand" – per the *Individual Beneficial Use Permit and Exemption for Foundry Sand (2023)*.

Figure 11: Foundry sand compiled on the Former Brook Park Ford Property. McBride Dale Clarion site evaluation photos, Photos Captured: 24 July 2026.

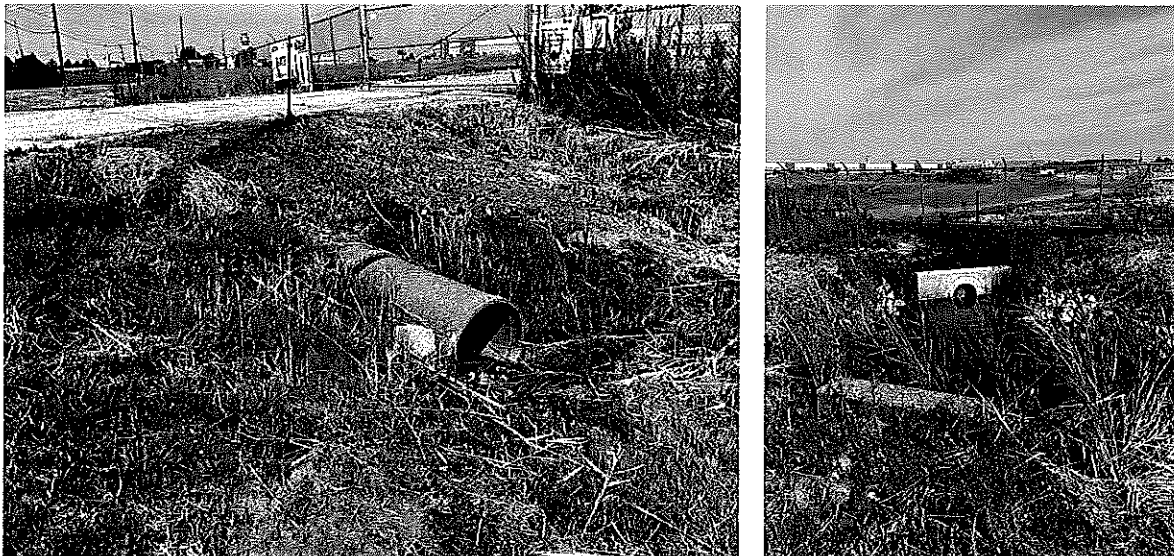
Figure 12: Off-site entrance culvert with standing water and broken sidewalk/sewer collection cover. McBride Dale Clarion site evaluation photos, Photos Captured: 24 July 2026.
